Rust Never Sleeps

Control chlorine use to safeguard tunnel washers

Rust Never Sleeps: Part II

Field-tested techniques aimed at reducing the threat of corrosion in today's batch tunnel washers

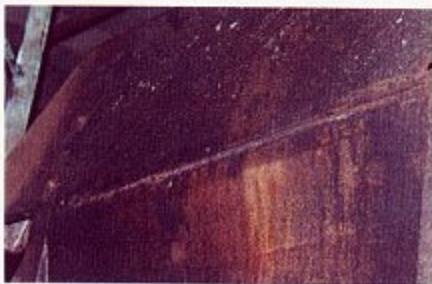
Photo #1 This image shows the face of a tunnel, which along with the press, was heavily damaged by corrosion. As the corrosive pattern rose from the mouth of the machine, it was

apparent that the damage was caused by a gas and was not consistent with contacting liquid or splashing. Examination of weirs, and the sides of the machine verified that only a gas could have created the damage seen. The material safety data sheets (MSDS) of the chemicals being used, injection sites and titrations, etc., were

observed to determine the source of the damage. The cause of this corrosion appeared to be high concentrations of chlorine bleach, too low pH and chlorine mixing with a fluoride-based sour.

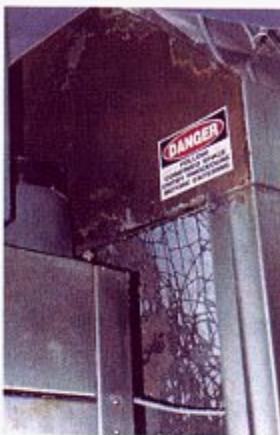
Photo #2 This tunnel had significant face plate and clean end cylinder rust damage. Ironically, a new tunnel of the same manufacture was installed right next to the old one. At the time of the installation of the new tunnel, the chemical company switched from a fluoride-based sour to a phosphoric-based sour. After several years of operation, the new tunnel, which utilized phosphoric sour, had no corrosion. The older tunnel that had previously used fluoride-based sour exhibited no increase in corrosion. In some cases,

we have seen a reduction in the corrosion process when the change to phosphoric acid was made. Note: the corrosion seen on this tunnel should be cleaned, and the metal should be repassivated.

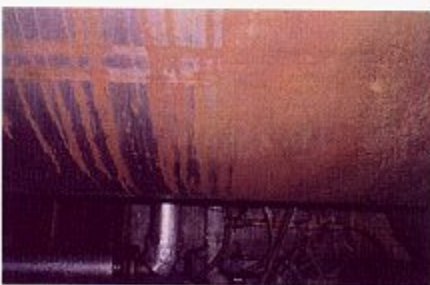
Photo #4 I did not see this machine, however, the damage was limited to the clean end of the tunnel. The sour bath injection port corroded away, reportedly causing extensive damage

to the support system. This damage can be seen to the right side of the picture. The subsequent leakage of the fluoride-based sour from the port caused the chemicals to spray onto the stainless steel cylinder. **TR**
